### XCF00S PROM Errata and Deviations from XCF00S Data Sheet

DS123-E02 (v1.1) May 26, 2004

Errata Notice

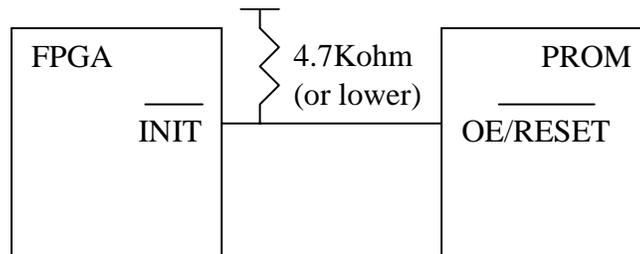
Figure 4: Recommended Resistor Value

A pull-up resistor is required to properly propagate this signal through the PROM (Figure 1); Figure 2 shows a clean OE/RESET# (INIT#) signal. However, a slow ramp could potentially allow system noise to propagate through the PROM's input buffer (Figure 3), thus creating short reset pulses that might cause the internal circuits to get out of sync. The observed failure rate ranges from 1% to 5% of configuration cycles.

Follow the data sheet to ensure that an external 4.7 KΩ (or lower) resistor is connected to the PROM's OE/RESET# pin and the FPGA's INIT# pin. Ensure that the FPGA TICCK specification is met (500ns). This translates to a Trise and Tfall time of 500ns for the PROM's OE/RESET# signal.

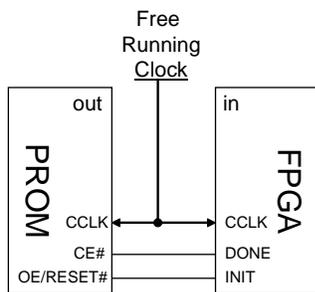
Figure 10: Asynchronous System

In most applications, the FPGA sources the CCLK signal, which synchronizes with the CE# (DONE) and OE/RESET# (INIT#) signals. However, in an asynchronous system (Figure 10), meaning when an external free-running clock drives the configuration clock signal (CCLK), then there is a probability that a missed or extra pulse(s) can be interpreted by the PROM's internal counters as CCLK transitions while the OE/RESET# (INIT#) signal is in its intermediate phase (Figure 11). The observed failure rate ranges from 0.1% to 1% of configuration cycles.

There is no application work-around that will avoid exposure to the phenomenon when a free running clock is used. Customers must design a system that does not utilize a free-running clock for configuration, such as utilizing the FPGA's internal clock to drive CCLK during configuration, or Master-Serial configuration mode.

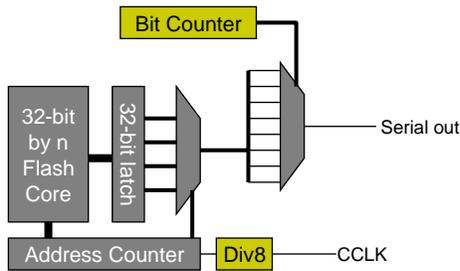
Figure 12: Counter Circuits

A Rotated Bit Pattern occurs when the Bit Counter and the Div8 circuit (Figure 12) becomes desynchronized. Data bits within a byte will be consistently rotated, byte by byte (Figure 13). Table 3 (above) summarizes the conditions where a Rotate Bit Pattern can occur.

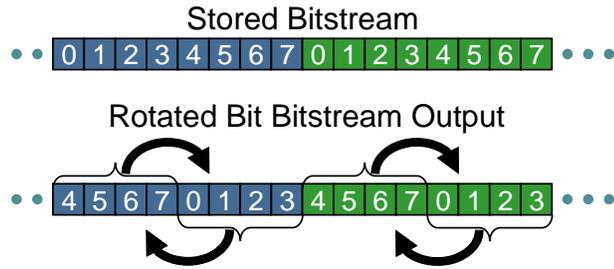
Figure 13: Example of Rotated Bit Pattern

Above diagram shows example of circuits being 4 bits out of sync

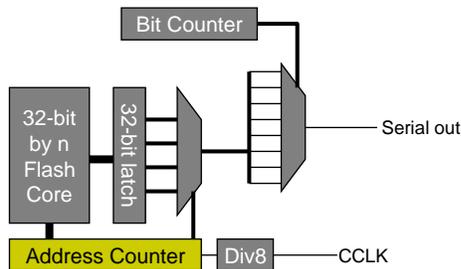
Figure 14: Counter Circuits

The Address Counter misses the first increment and repeats the first 32 bits. Table 3 (above) summarizes the conditions where an Extra 32 Bits pattern can occur.

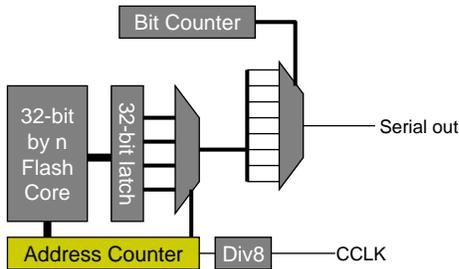
Figure 16: Counter Circuits

The Address Counter increments more than once and misses the second 32 bits. Table 3 (above) summarizes the conditions where a Missing 32 Bits pattern can occur.
