WP208 (v1.1) January 14, 2004

# *Flip-Chip Package Substrate Solder Issue*

*By: Abhay Maheshwari and Austin Lesea*

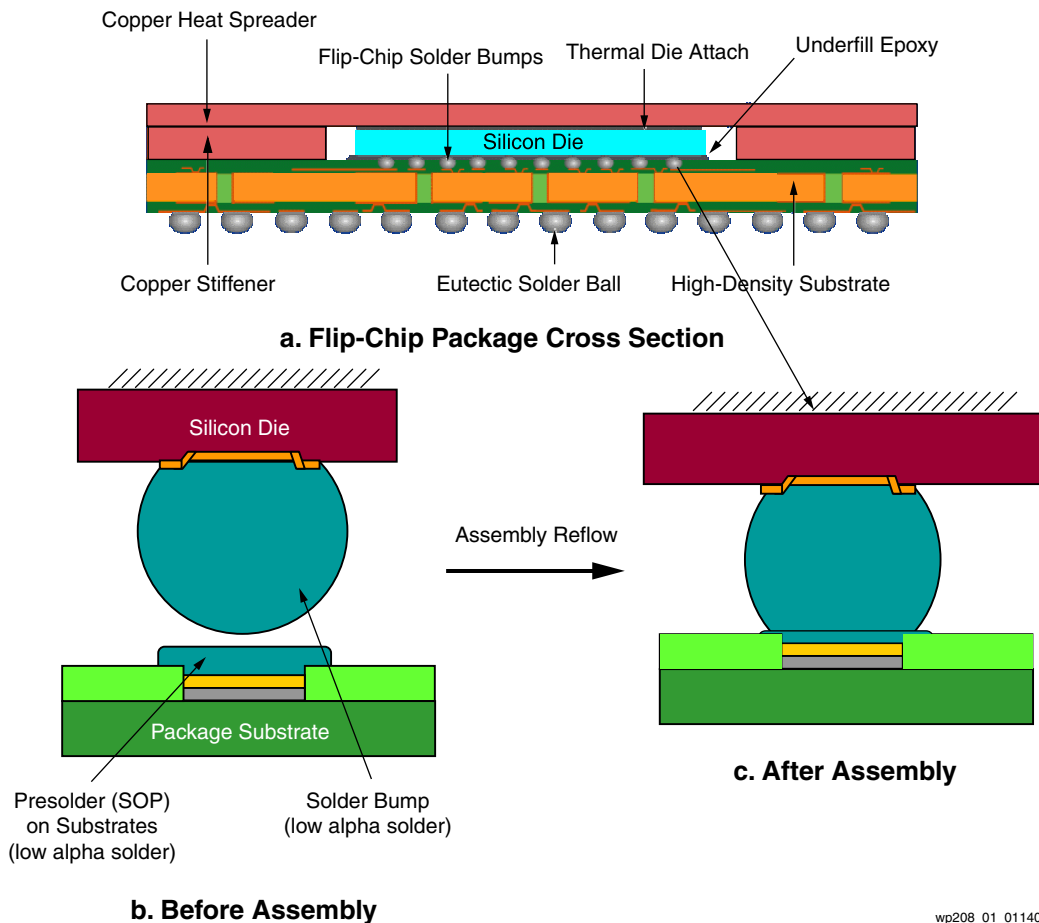
**Figure 1: Solder Bump Interconnection within Flip-Chip Packages**

Xilinx flip-chip packages are assembled using a solder bump interconnection process. **Figure 1a** shows the cross section of a flip-chip package. The active side of the silicon die contains an area array of pads on which solder bumps are attached. The package substrate pads also contain solder paste (presolder or SOP) that melts during assembly to form the solder bump interconnection, as shown in **Figure 1b** and **Figure 1c**.

Xilinx recently determined that one package substrate vendor was not in compliance with our low alpha solder requirements on package substrate pads. As a result, the solder bump interconnections on some of these devices were contaminated by small amounts of high alpha solder. The increased rate of alpha particle emission from the bumps can cause a configuration bit to be “flipped” to its opposite state (“flipped bits”) causing soft errors. Based on recent data, we anticipate one flipped bit per device at the rate of once every 230 to 2500 hours of continuous operation, depending on the device. The bit flip rate for this issue is proportional to the number of solder bumps directly over configuration memory cells. It also is dependent on the alpha particle emission rate of the solder, which can vary by a factor of 10. The estimated bit

This soldering issue has been resolved and does not affect device and package combinations assembled from January 1, 2004 (date code 0401) and later.
