Customer Advisory: Flip-Chip Package Substrate Solder Issue

CA2003-10 (v1.3) January 19, 2004

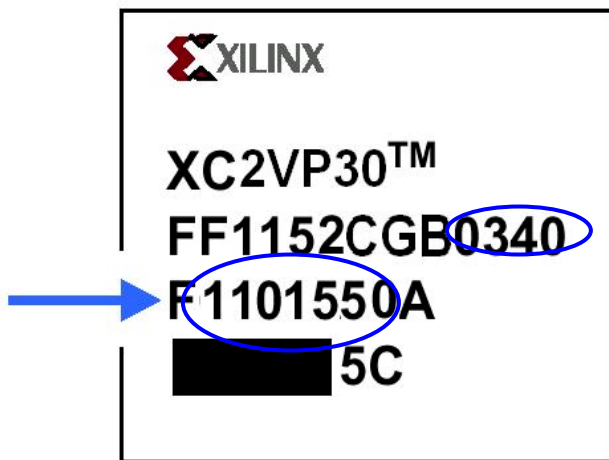
Example of a Package Topmark

Line 3: Package Code, 3-letter code (Circuit Rev, Wafer Fab Location, Geometry), and **Date Code (YYWW)** YY=year and WW=Work Week

Line 4: Mark Lot Number **(Refer to this portion of the top-side mark)**

Example as shown Lot # 1101550
