### CoolRunner™ XPLA3 CPLD Errata

DS012-E10 (v1.0) May 21, 2004

Errata Notification

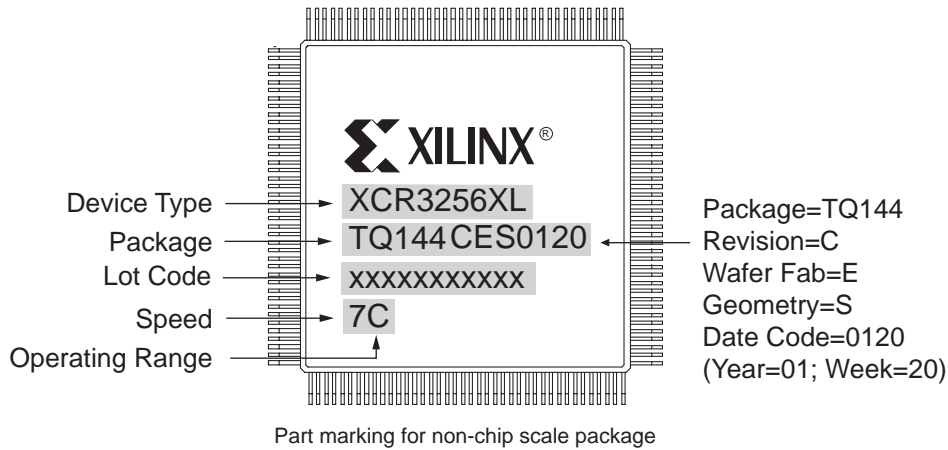
Figure 1. Example XCR3xxxXL Package Markings

These errata affect all CPLDs marked with an “XCRxxxXL” device type as shown in [Figure 1](#).
