### XC18V00 PROM Errata and Deviations from XC18V00 Data Sheet

DS026-E01 (v1.1) March 10, 2004

Errata Notice

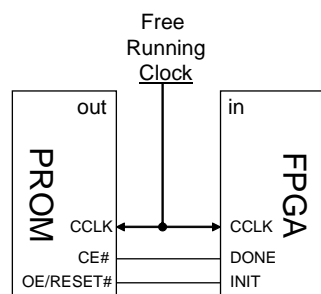
Figure 10: Asynchronous System

In most applications, the FPGA sources the CCLK signal, which synchronizes with the CE# (DONE) and OE/RESET# (INIT#) signals. However, in an asynchronous system (Figure 10), meaning when an external free-running clock drives the configuration clock signal (CCLK), there is a possibility that a missed or extra pulse (or pulses) can be interpreted by the PROM's internal counters as CCLK transitions while the OE/RESET# (INIT#) signal is in its intermediate phase (Figure 11). The observed failure rate ranges from 0.1% to 1% of configuration cycles.

There is no application work-around that will avoid exposure to the phenomenon when a free running clock is used. Therefore, customers who are using an external free-running clock need to convert their ordering code to SCD0799; this will ensure that they will not receive affected devices identified in Table 1, Table 2, and Table 3.

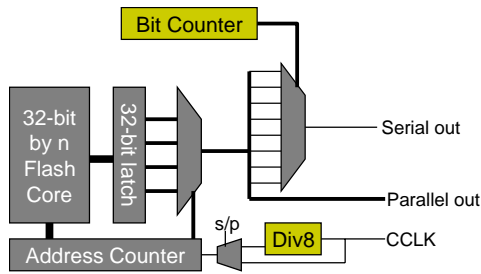
Figure 12: Counter Circuits

A Rotated Bit Pattern occurs when the Bit Counter and the Div8 circuit (Figure 12) becomes desynchronized. Data bits within a byte will be consistently rotated, byte by byte (Figure 13). Table 4 (above) summarizes the conditions where a Rotate Bit Pattern can occur.

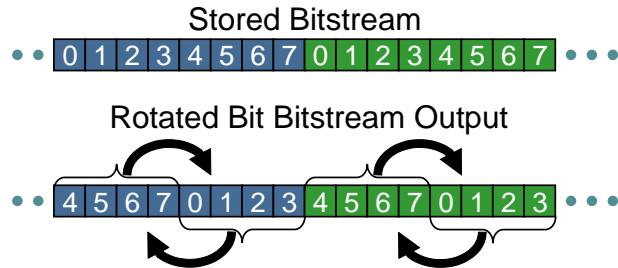
Figure 13: Example of Rotated Bit Pattern

Above diagram shows example of circuits being 4 bits out of sync

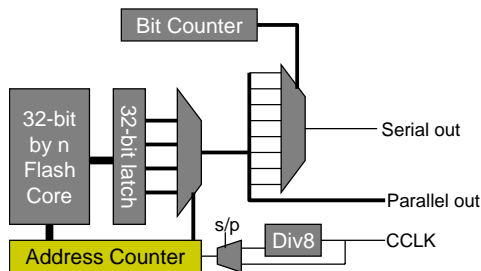
Figure 14: Counter Circuits

The Address Counter misses the first increment and repeats the first 32 bits. Table 4 (above) summarizes the conditions where an Extra 32 Bits pattern can occur.

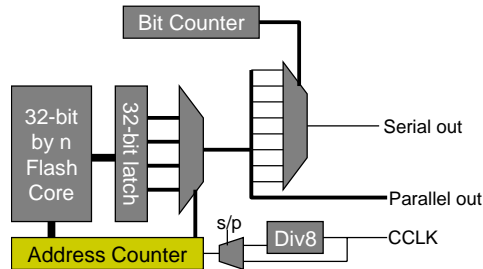
Figure 16: Counter Circuits

The Address Counter increments more than once and misses the second 32 bits. Table 4 (above) summarizes the conditions where a Missing 32 Bits pattern can occur.
