Introduction

Thank you for your interest in the Xilinx XCF08P, XCF16P, & XCF32P PROM products. Although Xilinx has made every effort to ensure the highest possible quality, these devices are subject to the limitations described in this Errata notification.

This erratum applies only to the XCF08P, XCF16P, & XCF32P PROMs. This erratum does not apply to any other Xilinx PROMs.

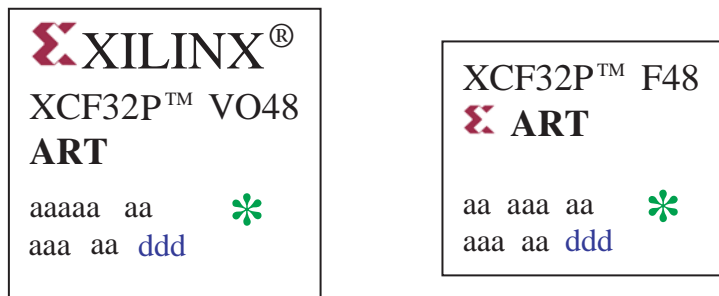
Figure 1: Left, TSOP-48 (VO48) Package; right, FBGA-48 (FS48) Package
Legend: a = alphanumeric characters; ddd = 3-character numeric date code.

The affected devices have date codes 522 and older (i.e., work week 22 in the year 2005, or older).

1. Ensure that VCCint ramps up to 1.6V faster than 1ms for the affected devices listed above
2. Xilinx implemented a test program to ensure the devices meet the Power on Reset Activation specification. Order parts that have been screened. Screened parts will have an asterisk mark (“*”) on the top side (see Figure 1, above). For ordering instructions, please contact your Xilinx Sales Representative.

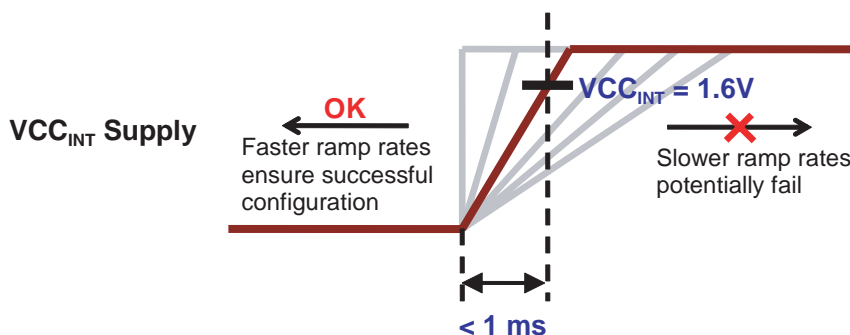
Figure 2: Requirements for VCC_{INT}

Some of the devices listed above may fail in some applications during “Power on Reset Activation.” Devices that have a VCCint ramp during “Power on Reset Activation” that is slower than 1ms may see failures.

XCF08P, XCF16P, and XCF32P devices that have a VCCint ramp during “Power on Reset Activation” that take longer than 1ms to reach 1.6V may potentially see failures. The following diagram describes the region of operation for parts that are affected by the errata.

These products have been in high volume production since December 2004 without failures until recently from two customers. These devices failed to power up correctly during prototyping or manufacturing test. All or some of the following symptoms might occur during power up:

- The PROM JTAG IDCODE is all 1's
This will prevent the programming of the FPGA bitstream into the PROM, because the programming solution (such as, a 3rd party programmer, a Xilinx cable/desktop programmer, etc.) will fail to recognize the PROM.
- PROM OE/RESET (FPGA INIT_B) is held Low from power-up and is never released High
This will prevent the FPGA from configuring.
- No data output from PROM
This will prevent the FPGA from configuring.

Xilinx implemented a test program to correct the errata and ensure the devices meet the Power on Reset Activation specification
