These errata apply **ONLY** to Spartan-3 XC3S200 FPGAs, including both production devices and engineering samples. These errata **DO NOT** apply to any other Spartan-3 FPGA. If using a different Spartan-3 FPGA, check for errata specific to that device.

## Devices Affected by This Errata

## Hardware Errata Summary

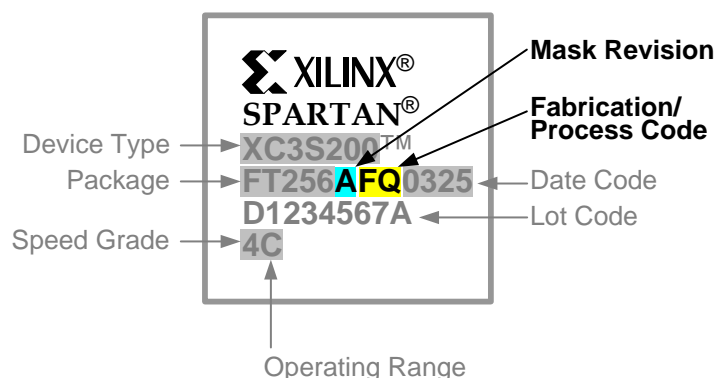
Figure 1: Spartan-3 FPGA from UMC 200 mm facility with “FQ” Fabrication/Process Code Marking

This issue only affects the XC3S200 FPGAs shown in [Table 4](#), marked with the “AFQ” mask/fabrication/process code as shown in [Figure 1](#).

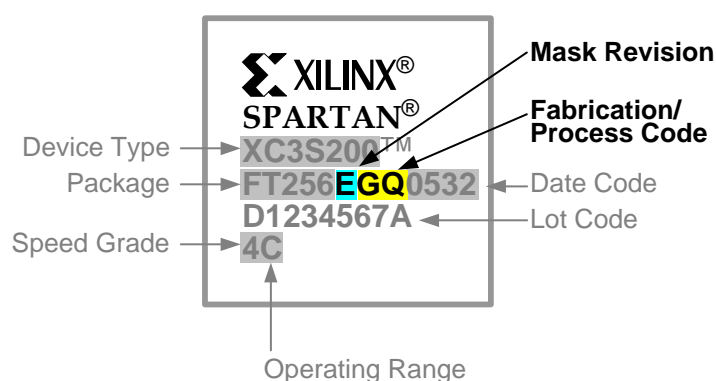
Figure 2: Spartan-3 FPGA from UMC 300 mm facility with “GQ” Fabrication/Process Code Marking

This issue is corrected on XC3S200 FPGAs with a “BGQ” mask/fabrication/process code marking, as shown in [Figure 2](#).

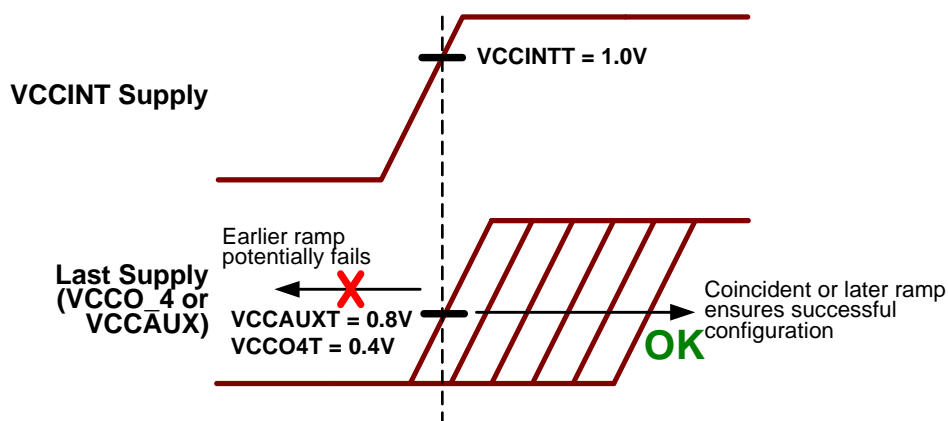
In the potentially failing condition, the VCCINT supply must be the last supply to reach its valid POR voltage and the ramp rate must be slower than 500  $\mu$ S. When the FPGA fails to configure, the INIT\_B remains Low and the FPGA ignores the PROG\_B program pin. Even with the worst identified power sequence, actual failures only occur on a small percentage of devices, typically measured in parts per million. The issue is more pronounced at cold temperatures.

Figure 3: Requirements when VCCINT is not the Last Supply

**OPTION 2:** Use a power-on sequence where VCCINT is not the last supply to reach its POR threshold level.

VCCINT must reach its maximum POR threshold ( $V_{CCINTT} = 1.0V$ ) before or coincident with VCCAUX reaching its minimum threshold ( $V_{CCAUXT} = 0.8V$ ). This supply sequence and threshold relationship is illustrated in [Figure 3](#).

Alternatively, VCCINT must reach its maximum POR threshold ( $V_{CCINTT} = 1.0V$ ) before or coincident with VCCO\_4 supplying I/O bank 4 reaching its minimum threshold ( $V_{CCO4T} = 0.4V$ ). This supply sequence and threshold relationship is also illustrated in [Figure 3](#).

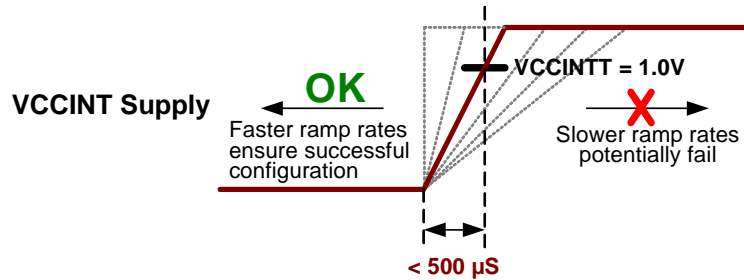
Figure 4: Use Faster VCCINT Ramp Rate if VCCINT is Last Supply

**OPTION 3:** In a system that requires that the VCCINT supply is last in the power-up sequence, ensure that it ramps to its maximum POR threshold voltage ( $V_{CCINTT} = 1.0V$ ) in less than  $< 500 \mu S$ , as shown in [Figure 4](#).

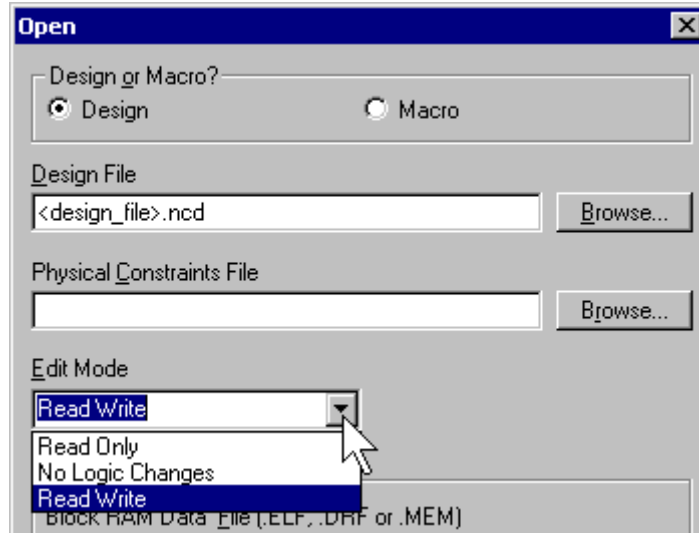
Figure 5: Enable User Editing in FPGA Editor

- Invoke the FPGA Editor. On Windows PCs, select **Start → Xilinx ISE 6 → Accessories → FPGA Editor**.
- Select **File → Open**. Select the \*.ncd file for the completed design. Set the **Edit Mode** to "Read Write" mode as shown in [Figure 5](#).
