These errata apply **ONLY** to Spartan-3 XC3S400 FPGAs, including both production devices and engineering samples. These errata **DO NOT** apply to any other Spartan-3 FPGA. If using a different Spartan-3 FPGA, check for errata specific to that device.

Obtaining the Most-Recent Errata Version

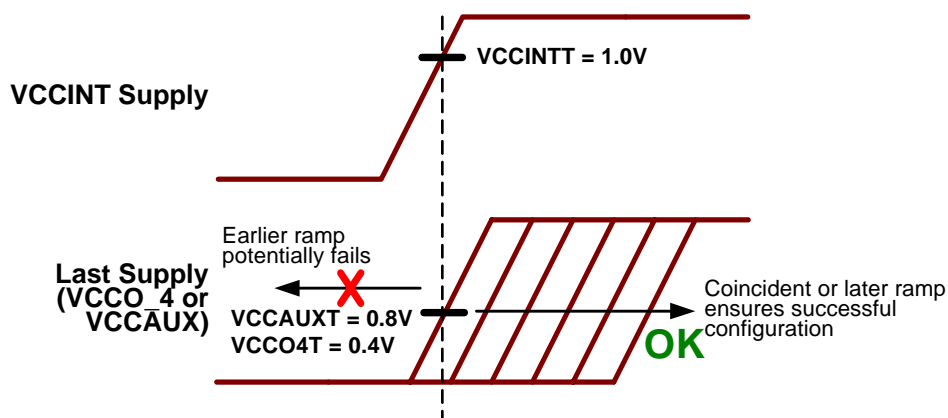
Figure 3: Requirements when VCCINT is not the Last Supply

In the potentially failing condition, the VCCINT supply must be the last supply to reach its valid POR voltage and the ramp rate must be slower than 500 μ S. When the FPGA fails to configure, the INIT_B remains Low and the FPGA ignores the PROG_B program pin. Even with the worst identified power sequence, actual failures only occur on a small percentage of devices, typically measured in parts per million. The issue is more pronounced at cold temperatures.

OPTION 2: Use a power-on sequence where VCCINT is not the last supply to reach its POR threshold level.

VCCINT must reach its maximum POR threshold ($V_{CCINTT} = 1.0V$) before or coincident with VCCAUX reaching its minimum threshold ($V_{CCAUXT} = 0.8V$). This supply sequence and threshold relationship is illustrated in [Figure 3](#).

Alternatively, VCCINT must reach its maximum POR threshold ($V_{CCINTT} = 1.0V$) before or coincident with VCCO_4 supplying I/O bank 4 reaching its minimum threshold ($V_{CCO4T} = 0.4V$). This supply sequence and threshold relationship is also illustrated in [Figure 3](#).

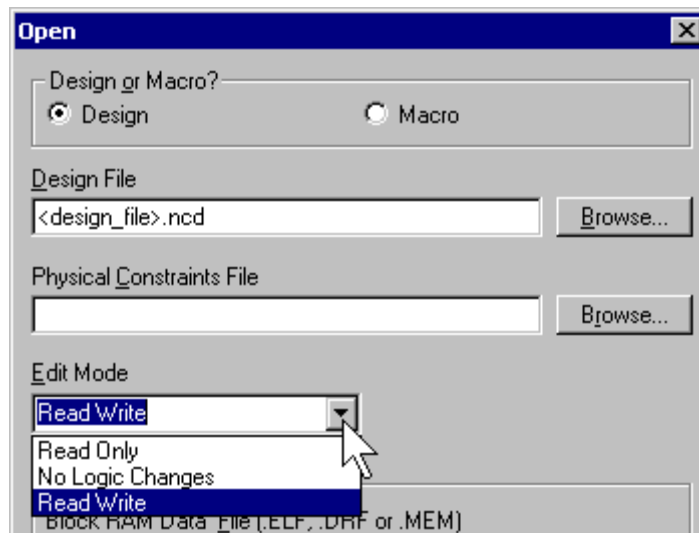
Figure 5: Enable User Editing in FPGA Editor

The DCM automatically compensates for process, voltage, and temperature (PVT) changes and consequently it periodically updates its delay tap settings. The rate at which the update occurs is controlled by an internal attribute called FACTORY_JF. Xilinx has identified an optimal FACTORY_JF setting value (FACTORY_JF=8080). Other settings may potentially fail to track properly over process, voltage, and temperature.

- Invoke the FPGA Editor. On Windows PCs, select **Start → Xilinx ISE 6 → Accessories → FPGA Editor**.
- Select **File → Open**. Select the *.ncd file for the completed design. Set the **Edit Mode** to "Read Write" mode as shown in [Figure 5](#).
