These errata apply **ONLY** to Spartan-3 XC3S400 FPGAs, including both production devices and engineering samples. These errata **DO NOT** apply to any other Spartan-3 FPGA. If using a different Spartan-3 FPGA, check for errata specific to that device.

Table 1: Spartan-3 XC3S400 FPGAs Affected by This Errata

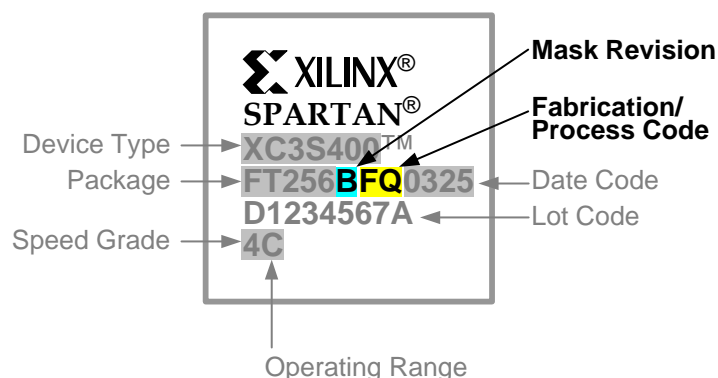
Figure 1: Spartan-3 FPGA from UMC 200 mm facility with “FQ” Fabrication/Process Code Marking

This issue only affects the XC3S400 FPGAs shown in [Table 4](#), marked with the “BFQ” mask/fabrication/process code as shown in [Figure 1](#).

The DCM compensates for delay on the routing network by monitoring an output clock, either CLK0 or CLK2X, through a BUFGMUX. If a design uses the CLK2X output as the feedback clock for a DCM, the LOCKED output may go Low and the DCM may stop operating correctly after tens of milliseconds.

This issue only affects the XC3S400 FPGAs shown in [Table 6](#), marked with the “BFQ” mask/fabrication/process code as shown in [Figure 1](#).

The dedicated configuration input pins may be inadvertently forced High or Low during a JTAG INTEST operation.

However, if the INTEST operation drives HSWAP\_EN Low during an UPDATE\_DR operation, then the FPGA restarts its configuration process. Because PROG\_B follows HSWAP\_EN in the JTAG chain, the Low in HSWAP\_EN shifts into PROG\_B, inadvertently triggering a device reconfiguration.

This issue only affects the XC3S400 FPGAs shown in [Table 7](#), marked with the "BFQ" mask/fabrication/process code as shown in [Figure 1](#).

A High (the default) on HSWAP\_EN disables weak pull-up resistors on all pins that are not actively involved in the configuration process, placing these pins in a high-impedance state. At the very end of the configuration process, the pull-up resistors within each user-I/O pin are momentarily enabled, just before the I/Os become operational.

Use feedback from the CLK0 (through a BUFGMUX) instead of CLK2X and change the CLK\_FEEDBACK attribute from 2X to 1X. There is no difference in DCM performance. The CLK2X output is still valid and available for the application but it cannot be used for feedback to the CLKFB pin.

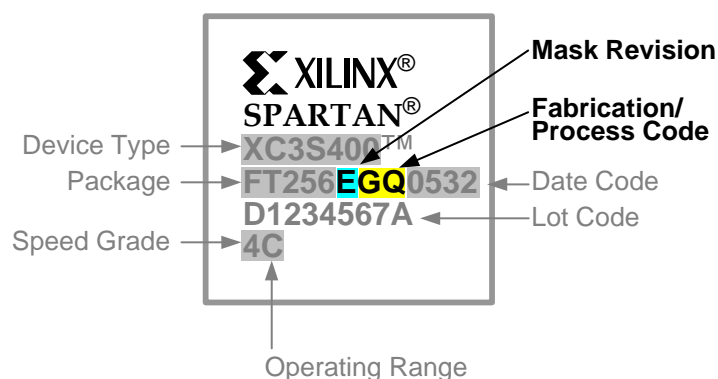
Figure 2: Spartan-3 FPGA from UMC 300 mm facility with “GQ” Fabrication/Process Code Marking

This issue only applies to those designs using the Readback feature on the XC3S400 FPGAs shown in [Table 8](#) with a "BGQ" Fabrication/Process Code marking, as shown in [Figure 2](#).

The readback feature is not available for the devices indicated in [Table 8](#).

This issue is corrected on XC3S400 FPGAs with a “BGQ” mask/fabrication/process code marking, as shown in [Figure 2](#).

This issue is corrected on XC3S400 FPGAs with a “BGQ” fabrication/process code marking, as shown in [Figure 2](#).

This issue is corrected on XC3S400 FPGAs with a "BGQ" fabrication/process code marking, as shown in [Figure 2](#).

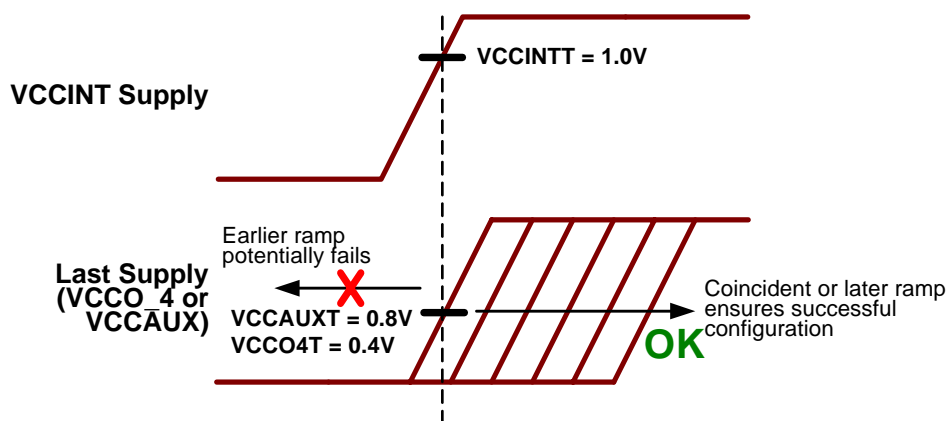
Figure 3: Requirements when VCCINT is not the Last Supply

In the potentially failing condition, the VCCINT supply must be the last supply to reach its valid POR voltage and the ramp rate must be slower than 500  $\mu$ S. When the FPGA fails to configure, the INIT\_B remains Low and the FPGA ignores the PROG\_B program pin. Even with the worst identified power sequence, actual failures only occur on a small percentage of devices, typically measured in parts per million. The issue is more pronounced at cold temperatures.

**OPTION 2:** Use a power-on sequence where VCCINT is not the last supply to reach its POR threshold level.

VCCINT must reach its maximum POR threshold ( $V_{CCINTT} = 1.0V$ ) before or coincident with VCCAUX reaching its minimum threshold ( $V_{CCAUXT} = 0.8V$ ). This supply sequence and threshold relationship is illustrated in [Figure 3](#).

Alternatively, VCCINT must reach its maximum POR threshold ( $V_{CCINTT} = 1.0V$ ) before or coincident with VCCO\_4 supplying I/O bank 4 reaching its minimum threshold ( $V_{CCO4T} = 0.4V$ ). This supply sequence and threshold relationship is also illustrated in [Figure 3](#).
