Readback Feature Not Available on Devices Built Before Date Code “0532”

Bitstream Update Required using ISE 6.3i, Service Pack 1 (SP1) or Later

New FACTORY_JF Settings Required for Spartan-3 DCMs

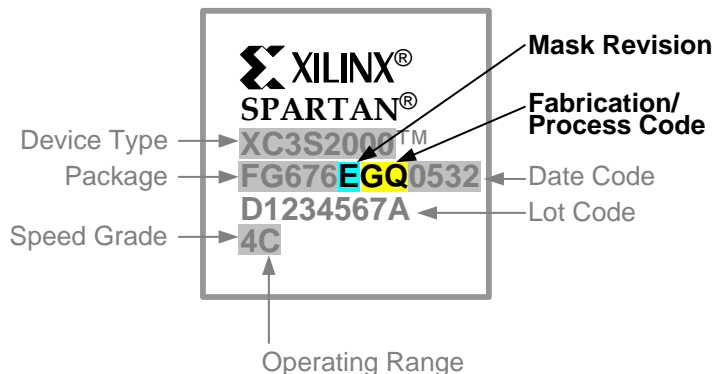
Figure 1: Spartan-3 FPGA from UMC 300 mm facility with “GQ” Fabrication/Process Code Marking

This issue only applies to those designs using the Readback feature on the XC3S2000 FPGAs shown in [Table 4](#) with either a “BGQ” Fabrication/Process Code marking or a date code prior to “0532”, as shown in [Figure 1](#).

XC3S2000 FPGAs with an “EGQ” Mask/Fabrication/Process Code marking and with a Date Code of “0532” or later fully support Readback. XC3S2000 FPGAs ordered using the standard part number (i.e., no SCD codes) scheduled for delivery after 15-AUG-2005 automatically include the latest mask revision and Readback functionality.
