These errata apply **ONLY** to Spartan-3 XC3S4000 and XC3S4000L FPGAs, including both production devices and engineering samples. These errata **DO NOT** apply to any other Spartan-3 FPGA. If using a different Spartan-3 FPGA, check for errata specific to that device.

## Obtaining the Most-Recent Errata Version

## Devices Affected by This Errata

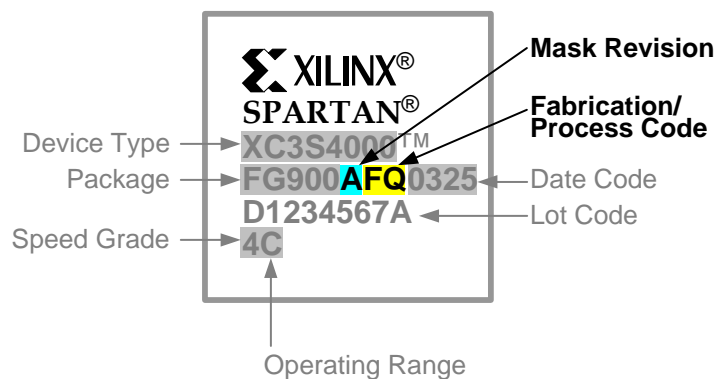
Figure 1: Spartan-3 FPGA from UMC 200 mm facility with “FQ” Fabrication/Process Code Marking

This issue only affects the XC3S4000 FPGAs shown in [Table 4](#), marked with the “AFQ” mask/fabrication/process code as shown in [Figure 1](#). Few such XC3S4000 FPGAs were ever built.

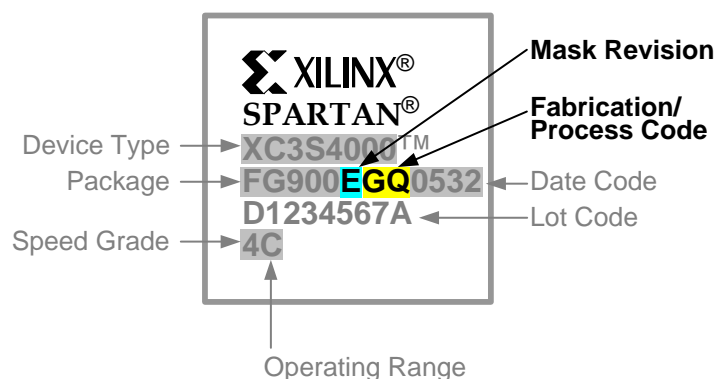
Figure 2: Spartan-3 FPGA from UMC 300 mm facility with “GQ” Fabrication/Process Code Marking

This issue is corrected on XC3S4000L FPGAs and on XC3S4000 FPGAs with a “GQ” fabrication/process code marking, as shown in [Figure 2](#).

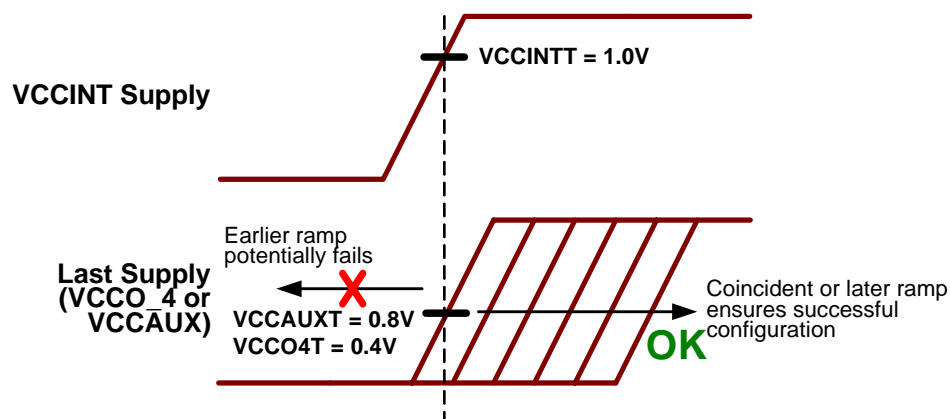
VCCINT must reach its maximum POR threshold ( $V_{CCINTT} = 1.0V$ ) before or coincident with VCCAUX reaching its minimum threshold ( $V_{CCAUXT} = 0.8V$ ). This supply sequence and threshold relationship is illustrated in [Figure 3](#).

Alternatively, VCCINT must reach its maximum POR threshold ( $V_{CCINTT} = 1.0V$ ) before or coincident with VCCO\_4 supplying I/O bank 4 reaching its minimum threshold ( $V_{CCO4T} = 0.4V$ ). This supply sequence and threshold relationship is also illustrated in [Figure 3](#).

Figure 3: Requirements when VCCINT is not the Last Supply

**OPTION 2:** Use a power-on sequence where VCCINT is not the last supply to reach its POR threshold level.

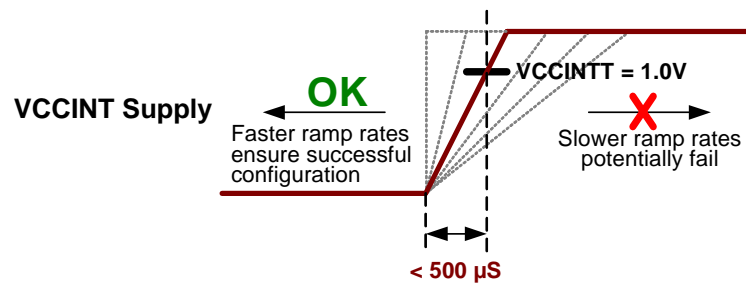
Figure 4: Use Faster VCCINT Ramp Rate if VCCINT is Last Supply

**OPTION 3:** In a system that requires that the VCCINT supply is last in the power-up sequence, ensure that it ramps to its maximum POR threshold voltage ( $V_{CCINTT} = 1.0V$ ) in less than < 500  $\mu$ S, as shown in [Figure 4](#).

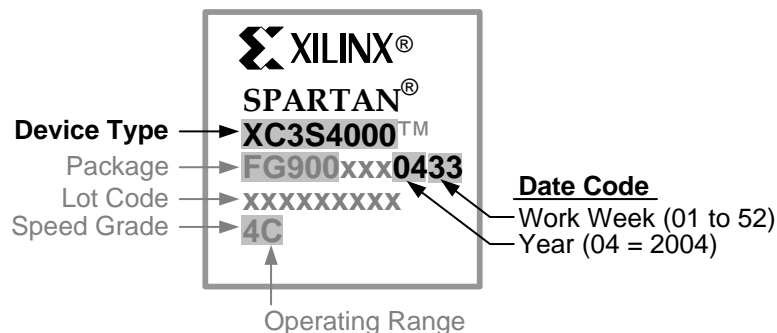
These new bitstream settings are now the default settings starting with Xilinx ISE 6.3i, Service Package 1, available for download from the Xilinx web site after September 13, 2004. XC3S4000 FPGAs are tested using these new bitstream settings beginning with date codes “0433”, corresponding to Work Week 33 of 2004. [Figure 5](#) shows an example top marking for a Spartan-3 FPGA. The relevant fields to identify an affected device are highlighted and include the **Device Type** and the **Date Code**.

Figure 5: Example Spartan-3 Package Markings

Please regenerate any Spartan-3 FPGA configuration bitstreams created using software versions prior to Xilinx ISE 6.3i development software, Service Pack 1. By updating the bitstream, the application can use any existing or future production Spartan-3 FPGA device.
