These errata apply **ONLY** to Spartan-3 XC3S4000 and XC3S4000L FPGAs, including both production devices and engineering samples. These errata **DO NOT** apply to any other Spartan-3 FPGA. If using a different Spartan-3 FPGA, check for errata specific to that device.

Thank you for your interest in Spartan-3 XC3S4000 or XC3S4000L FPGA devices. Although Xilinx has made every effort to ensure that these devices are of the highest possible quality, these devices are subject to the limitations described in the following errata. Please review these errata to ensure that XC3S4000 or XC3S4000L FPGA devices meet your application requirements. Xilinx wants you to know about any known issues that may potentially affect your Spartan-3 application. This notice also includes [advisories](#) on the latest Spartan-3 design practices.

Devices Affected by This Errata

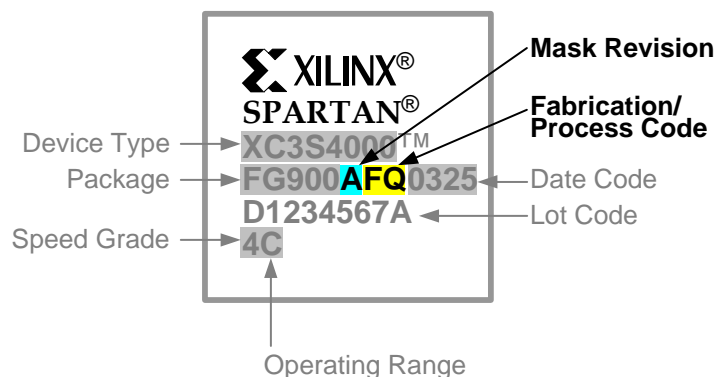
Figure 1: Spartan-3 FPGA from UMC 200 mm facility with “FQ” Fabrication/Process Code Marking

This issue only affects the XC3S4000 FPGAs shown in [Table 4](#), marked with the “AFQ” mask/fabrication/process code as shown in [Figure 1](#). Few such XC3S4000 FPGAs were ever built.

This issue only affects the XC3S4000 FPGAs shown in [Table 6](#), marked with the “AFQ” mask/fabrication/process code as shown in [Figure 1](#). Few such XC3S4000 FPGAs were ever built.

This issue only affects the XC3S4000 FPGAs shown in [Table 7](#), marked with the "AFQ" mask/fabrication/process code as shown in [Figure 1](#). Few such XC3S4000 FPGAs were ever built.
