These errata apply **ONLY** to Spartan-3 XC3S5000 FPGAs, including both production devices and engineering samples. These errata **DO NOT** apply to any other Spartan-3 FPGA. If using a different Spartan-3 FPGA, check for errata specific to that device.

### Readback Feature Not Available on Devices Built Before Date Code “0532”

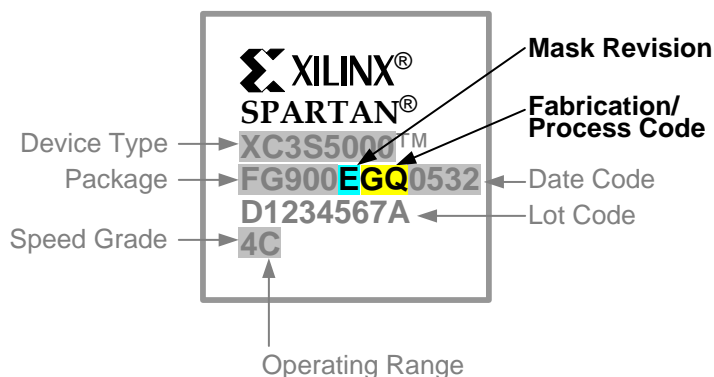
Figure 1: Spartan-3 FPGA from UMC 300 mm facility with “GQ” Fabrication/Process Code Marking

These errata affect all Spartan-3 FPGAs marked with an “XC3S5000” device type. XC3S5000 FPGAs are produced exclusively at the UMC 300 mm wafer facility using 90 nm process technology. Devices using the latest mask set have an “EGQ” mask/fabrication/process code, as shown in [Table 2](#). An earlier revision, “AGQ”, did not support the Readback feature.

This issue only applies to those designs using the Readback feature on the XC3S5000 FPGAs shown in [Table 4](#) with a “AGQ” Fabrication/Process Code marking or a date code prior to “0532”, as shown in [Figure 1](#).

XC3S5000 FPGAs with an “EGQ” Mask/Fabrication/Process Code marking and with a Date Code of “0532” or later fully support Readback. XC3S5000 FPGAs ordered using the standard part number (without SCD codes) scheduled for delivery after 15-AUG-2005 automatically include the latest mask revision and Readback functionality.

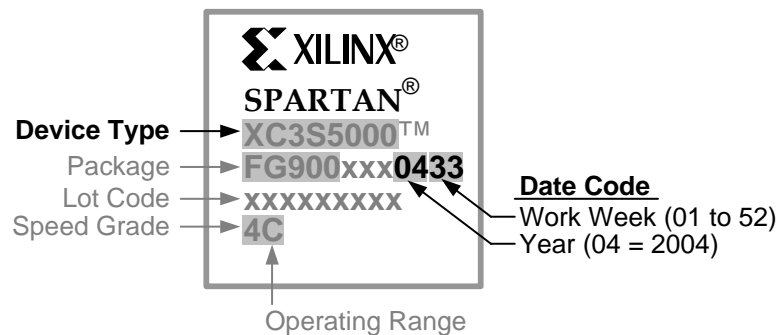
Figure 2: Example Spartan-3 Package Markings

These new bitstream settings are now the default settings starting with Xilinx 6.3i, Service Package 1, available for download from the Xilinx web site after September 13, 2004. XC3S5000 FPGAs are tested using these new bitstream settings beginning with date codes “0433”, corresponding to Work Week 33 of 2004. [Figure 2](#) shows an example top marking for a Spartan-3 FPGA. The relevant fields to identify an affected device are highlighted and include the **Device Type** and the **Date Code**.

**Please regenerate any Spartan-3 FPGA configuration bitstreams** created using software versions prior to Xilinx ISE 6.3i development software, Service Pack 1. By updating the bitstream, the application can use any existing or future production Spartan-3 FPGA device.
