Introduction

Thank you for your interest in the Xilinx Spartan™-3AN family XC3S400AN FPGA device engineering samples. Although Xilinx has made every effort to ensure the highest possible quality, these devices are subject to the limitations described in this errata notification. These errata do not apply to the XC3S400AN production FPGAs.

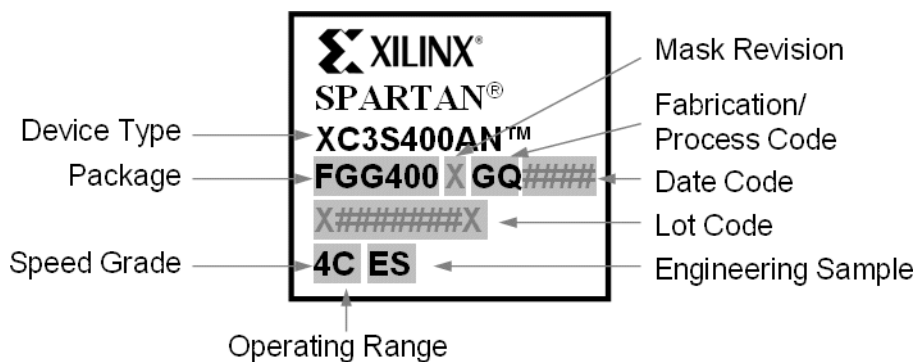
Figure 1: XC3S400AN FPGA Top Marking

XC3S400AN engineering samples are marked as shown in [Figure 1](#). The other devices listed in [Table 1](#) are marked similarly.
