## Introduction

Thank you for your interest in the Xilinx Spartan™-3AN family XC3S400AN FPGA device engineering samples. Although Xilinx has made every effort to ensure the highest possible quality, these devices are subject to the limitations described in this errata notification. These errata do not apply to the XC3S400AN production FPGAs.

## Device Identification

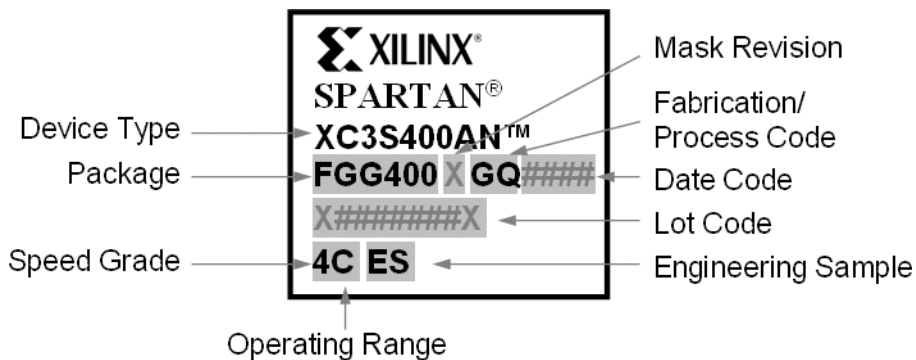
Figure 1: XC3S400AN FPGA Top Marking

XC3S400AN engineering samples are marked as shown in [Figure 1](#). The other devices listed in [Table 1](#) are marked similarly.
