Thank you for your interest in the Xilinx XC3S1400A FPGA device engineering samples. Although Xilinx has made every effort to ensure the highest possible quality, these devices are subject to the limitations described in this errata notification.

## Device Identification

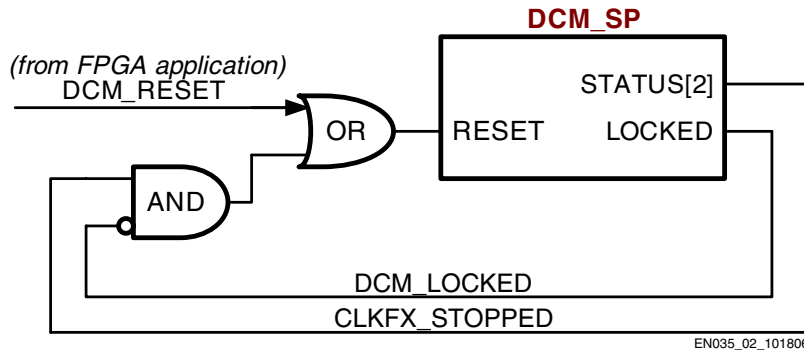
Figure 2: DCM DFS Lock Failure Workaround

A small number of DCM DFS locking failures have been observed during characterization.

A software workaround exists, as shown in [Figure 2](#). This circuit is automatically inserted by the ISE development software starting with version 9.1i. Using FPGA logic, the circuit monitors both the LOCKED output from the DCM\_SP function and the STATUS[2] bit, which indicates that the DFS output CLKFX has stopped. If LOCKED = 0 and STATUS[2] = 1, then the circuit asserts the DCM RESET input. If the FPGA application also resets the DCM, then OR the reset signal from the FPGA application with the monitored output signals.
