Introduction

Thank you for participating in the Spartan®-6 FPGA Engineering Sample Program. As part of this program, we are pleased to provide to you engineering samples of the devices listed in [Table 1](#). Although Xilinx has made every effort to ensure the highest possible quality, these devices are subject to the limitations described in the following errata.

Table 1: Devices Affected by These Errata

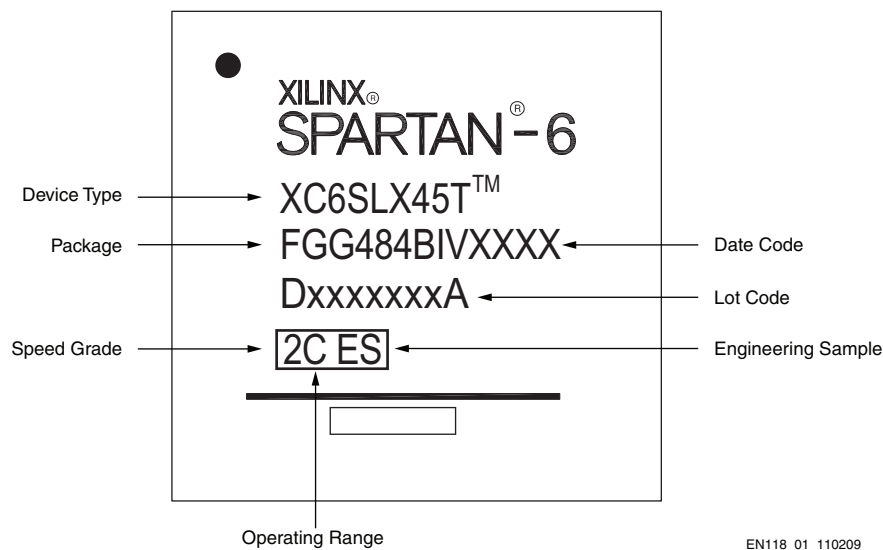
Figure 1: XC6SLX45T-2FGG484CES Marking

The XC6SLX45T is marked as shown in Figure 1. The other devices in Table 1 are marked similarly.
