These errata apply **ONLY** to Spartan-3 XC3S400 FPGAs, including both production devices and engineering samples. These errata **DO NOT** apply to any other Spartan-3 FPGA. If using a different Spartan-3 FPGA, check for errata specific to that device.

Obtaining the Most-Recent Errata Version

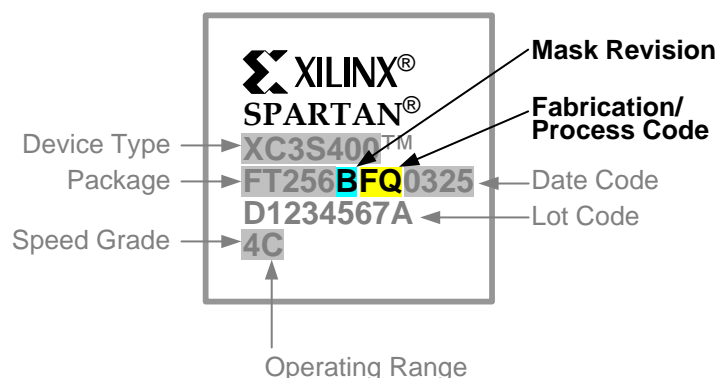
Figure 1: Spartan-3 FPGA from UMC 200 mm facility with “FQ” Fabrication/Process Code Marking

This issue only affects the XC3S400 FPGAs shown in [Table 4](#), marked with the “BFQ” mask/fabrication/process code as shown in [Figure 1](#).

This issue only affects the XC3S400 FPGAs shown in [Table 6](#), marked with the “BFQ” mask/fabrication/process code as shown in [Figure 1](#).

This issue only affects the XC3S400 FPGAs shown in [Table 7](#), marked with the "BFQ" mask/fabrication/process code as shown in [Figure 1](#).

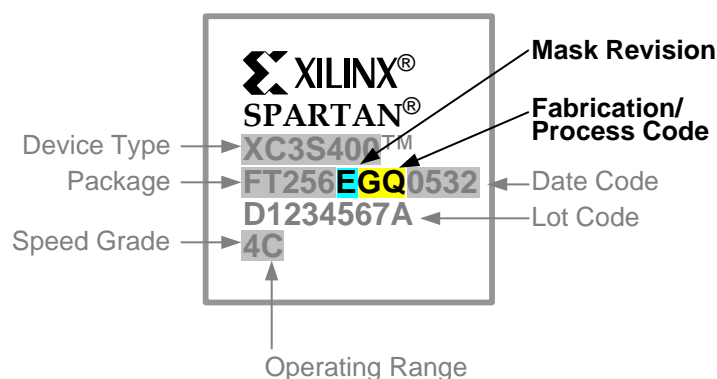
Figure 2: Spartan-3 FPGA from UMC 300 mm facility with “GQ” Fabrication/Process Code Marking

This issue is corrected on XC3S400 FPGAs with a “BGQ” mask/fabrication/process code marking, as shown in [Figure 2](#).

This issue is corrected on XC3S400 FPGAs with a “BGQ” fabrication/process code marking, as shown in [Figure 2](#).

This issue is corrected on XC3S400 FPGAs with a "BGQ" fabrication/process code marking, as shown in [Figure 2](#).

This issue only applies to those designs using the Readback feature on the XC3S400 FPGAs shown in [Table 8](#) with a "BGQ" Fabrication/Process Code marking, as shown in [Figure 2](#).
