## Introduction

Thank you for designing with the Xilinx Zynq®-7000 All Programmable SoC (AP SoC) family of devices. Although Xilinx has made every effort to ensure the highest possible quality, the devices listed in [Table 1](#) are subject to the limitations described in the following errata.

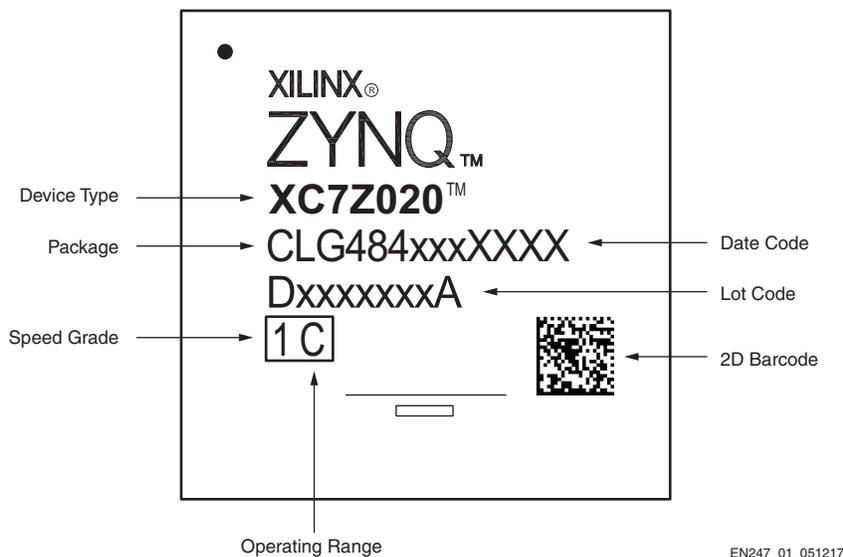
Figure 1: Example Device Top Mark

Figure 1 shows an example device top mark for the devices listed in Table 1. Refer to [XCEN16014](#) for details on the addition of the 2D barcode.

02/10/15	1.8	Added <a href="#">I2C Slave Monitor Mode Can Lock The I2C Bus</a> and <a href="#">I2C Transaction Corruption In Slave Receiver Mode</a> .
10/19/15	1.9	Added <a href="#">Under Very Rare Timing Circumstances, Transition Into Streaming Mode Might Create A Data Corruption</a> and <a href="#">When ECC Is Enabled, The CHE_CORR_ECC_ADDR_REG_OFFSET Register Might Report An Incorrect Column Address</a> .
09/27/16	1.10	Added single-core devices (XC7Z007S, XC7Z012S, and XC7Z014S) to <a href="#">Table 1</a> . Updated <a href="#">System Deadlock Can Occur In SMP Mode When The Same Cache Line Is Accessed By Both CPUs And The ACP</a> .
05/22/17	1.11	Updated <a href="#">Traceability</a> and <a href="#">Figure 1</a> with 2D barcode information.
