Introduction

Thank you for participating in the Xilinx Virtex™-4 Engineering Sample Program. As part of this program, we are pleased to provide to you engineering samples of the Virtex-4 XC4VLX100 FPGA. Although Xilinx has made every effort to ensure the highest possible quality, these devices are subject to the limitations described in the following errata.

Table 1: XC4VLX100 FPGA Devices Affected by These Errata

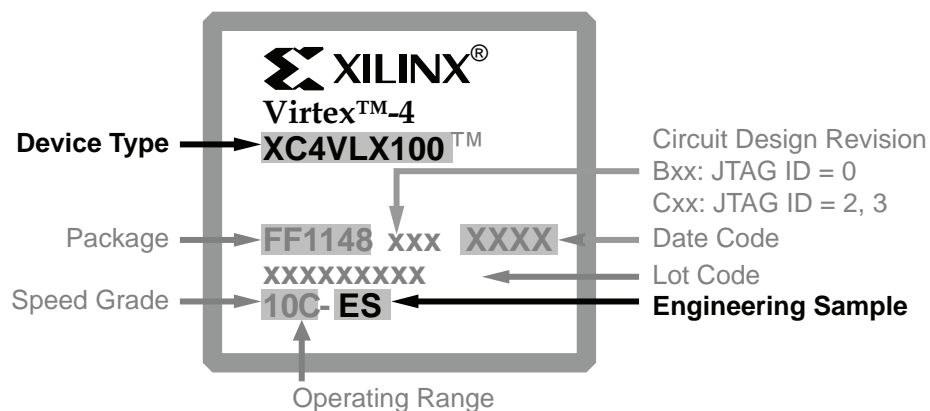
Figure 1: Example XC4VLX100CES Package Marking

The XC4VLX100 is marked as shown in [Figure 1](#).
