Introduction

Thank you for participating in the Xilinx Virtex™-4 Engineering Sample Program. As part of this program, we are pleased to provide to you engineering samples of the Virtex-4 XC4VSX55 FPGA. Although Xilinx has made every effort to ensure the highest possible quality, these devices are subject to the limitations described in the following errata.

These errata apply to the XC4VSX55 devices as shown in [Table 1](#).

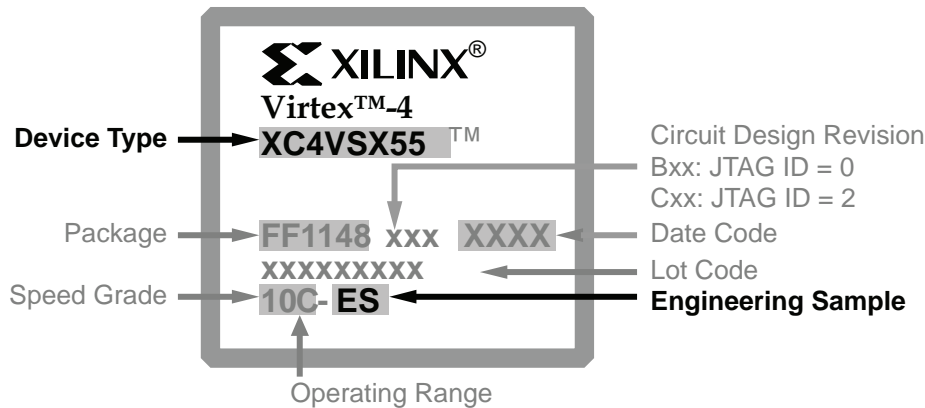
Figure 1: Example XC4VSX55CES Package Marking

The XC4VSX55 is marked as shown in Figure 1.
