## Introduction

Thank you for participating in the Xilinx Virtex™-4 Engineering Sample Program. As part of this program, we are pleased to provide to you engineering samples of the Virtex-4 XC4VLX80 FPGA. Although Xilinx has made every effort to ensure the highest possible quality, these devices are subject to the limitations described in the following errata.

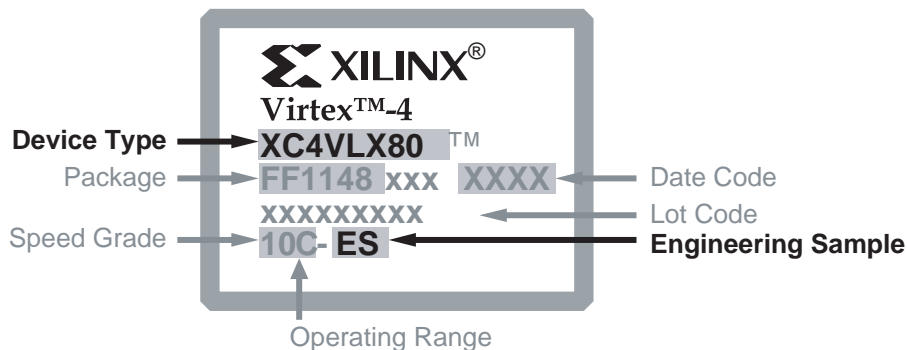
Figure 1: Example XC4VLX80CES Package Marking

The XC4VLX80 is marked as shown in Figure 1.
