Introduction

Thank you for participating in the Xilinx Virtex™-4 Engineering Sample Program. As part of this program, we are pleased to provide to you engineering samples of the Virtex-4 XC4VSX25 FPGA. Although Xilinx has made every effort to ensure the highest possible quality, these devices are subject to the limitations described in the following errata.

Hardware Errata Details (JTAG ID = 2)

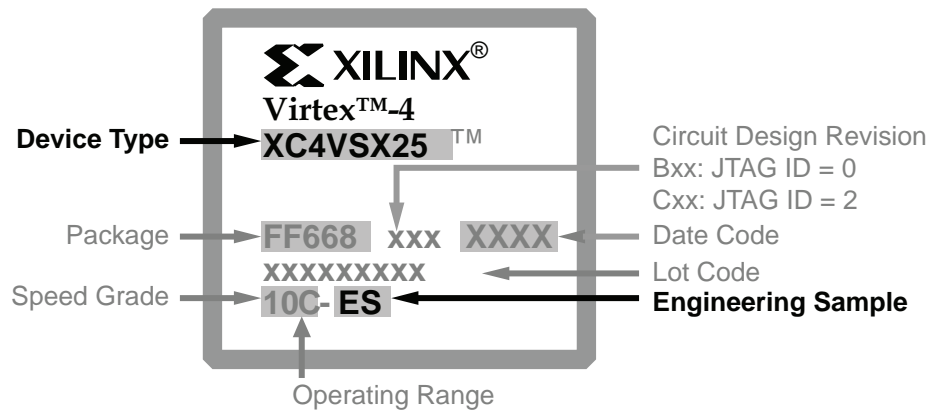
Figure 1: Example XC4VSX25CES Package Marking

The XC4VSX25 is marked as shown in Figure 1.
