Introduction

Thank you for participating in the Xilinx Virtex™-4 Engineering Sample Program. As part of this program, we are pleased to provide to you engineering samples of the Virtex-4 XC4VLX15 FPGA. Although Xilinx has made every effort to ensure the highest possible quality, these devices are subject to the limitations described in the following errata.

Table 1: XC4VLX15 FPGA Devices Affected by These Errata

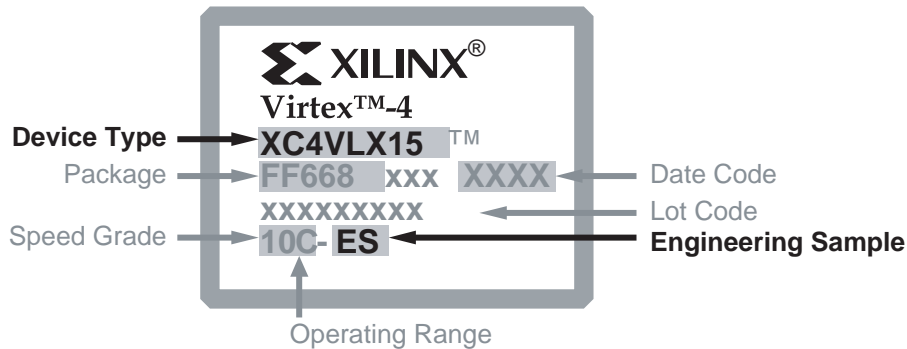
Figure 1: Example XC4VLX15CES Package Marking

The XC4VLX15 is marked as shown in Figure 1.
