Introduction

Although Xilinx has made every effort to ensure the highest possible quality, these Virtex[®]-5 FPGA engineering samples (ES) are subject to the limitations described in the following errata.

These errata apply to the Virtex-5 devices, as shown in [Table 1](#).

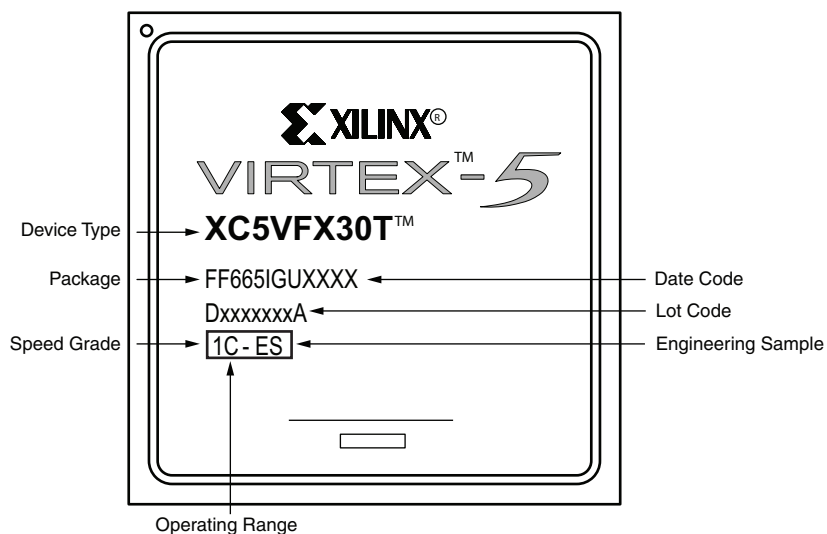
Figure 1: Example XC5VFX30T CES Package Marking

The XC5VFX30T CES is marked as shown in [Figure 1](#). The other devices listed in [Table 1](#) are marked similarly.
