## Introduction

Thank you for participating in the Spartan®-6 FPGA Engineering Sample Program. As part of this program, we are pleased to provide to you engineering samples of the device listed in [Table 1](#). Although Xilinx has made every effort to ensure the highest possible quality, this device is subject to the limitations described in the following errata.

These errata apply to the Spartan-6 device shown in [Table 1](#).

Device	JTAG ID (Revision Code)
XC6SLX16-2CSG324CES	1

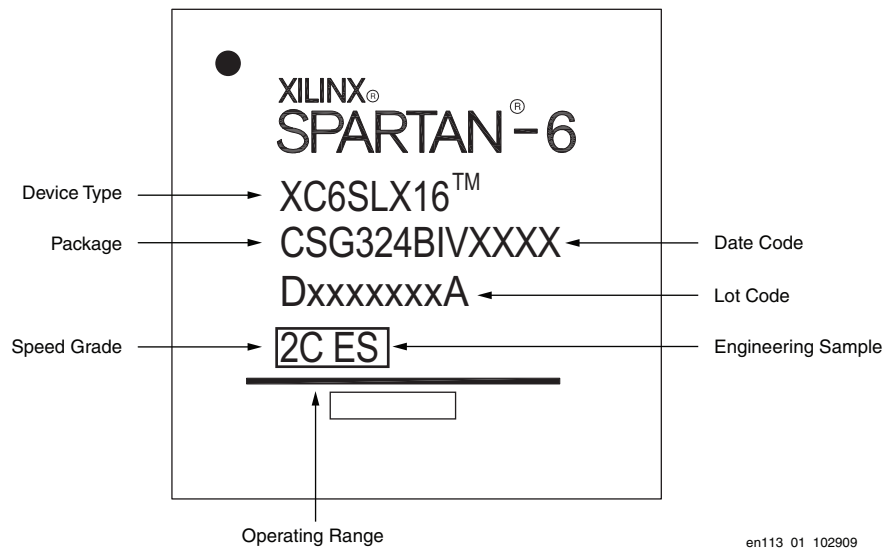
Figure 1: XC6SLX16-2CSG324CES Marking

The XC6SLX16 listed in Table 1 is marked as shown in Figure 1.
