Introduction

Thank you for participating in the Spartan®-6 FPGA Engineering Sample Program. As part of this program, we are pleased to provide to you engineering samples of the devices listed in [Table 1](#). Although Xilinx has made every effort to ensure the highest possible quality, these devices are subject to the limitations described in the following errata.

Hardware Errata Details

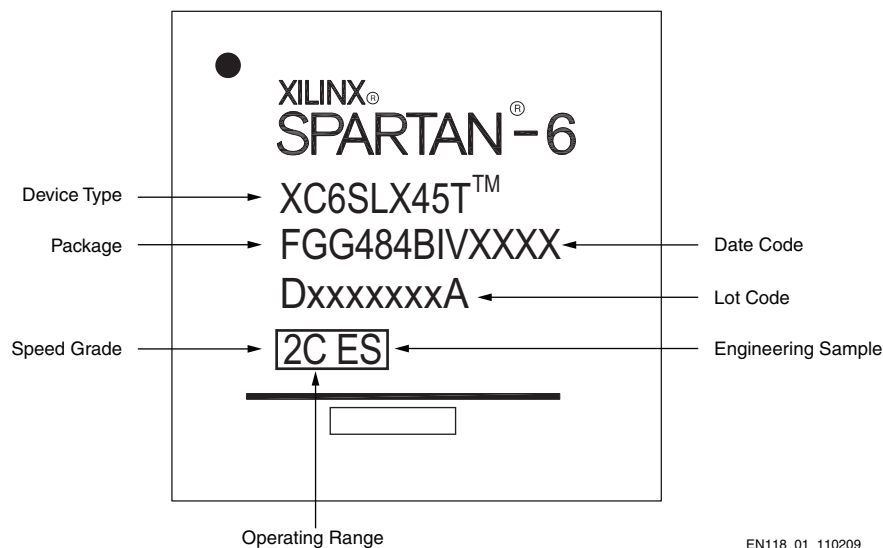
Figure 1: XC6SLX45T-2FGG484CES Marking

The XC6SLX45T is marked as shown in Figure 1. The other devices in Table 1 are marked similarly.
