Introduction

Thank you for participating in the Zynq®-7000 All Programmable SoC (AP SoC) Engineering Sample Program. As part of this program, we are pleased to provide to you engineering samples of the devices listed in [Table 1](#). Although Xilinx has made every effort to ensure the highest possible quality, these devices are subject to the limitations described in the following errata.

Table 1: Devices Affected by These Errata

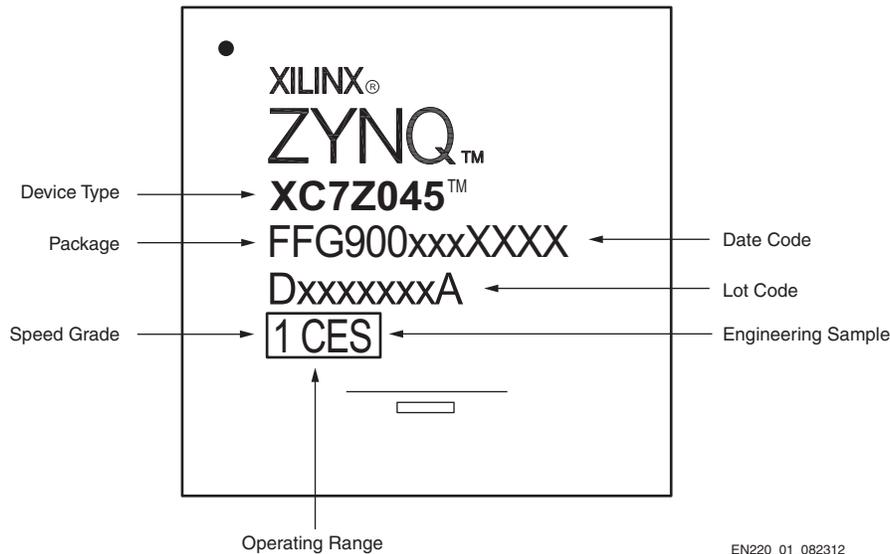
Figure 1: Example Device Top Mark

Figure 1 shows an example device top mark for the devices listed in Table 1.
