Introduction

Thank you for designing with the Xilinx Zynq®-7000 All Programmable SoC (AP SoC) family of devices. Although Xilinx has made every effort to ensure the highest possible quality, the devices listed in [Table 1](#) are subject to the limitations described in the following errata.

Processor System (PS) Errata Details

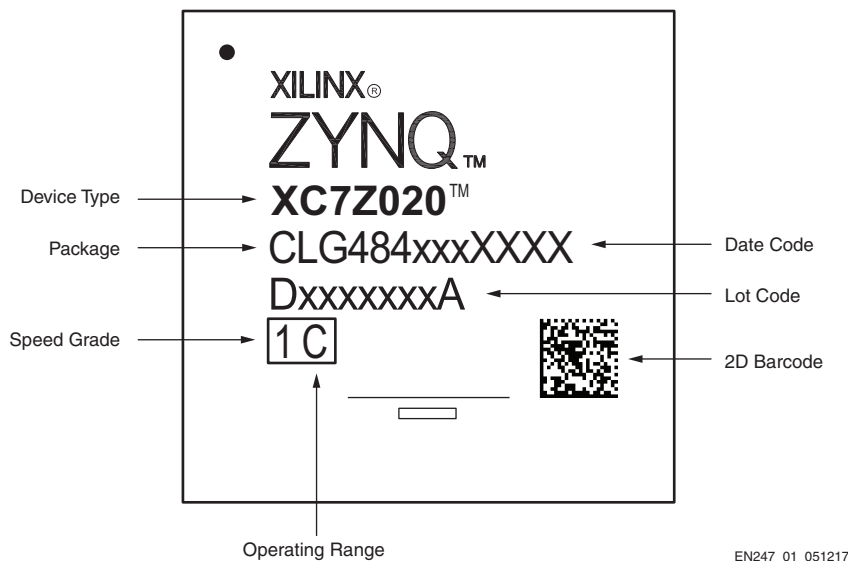
Figure 1: Example Device Top Mark

Figure 1 shows an example device top mark for the devices listed in Table 1. Refer to [XCEN16014](#) for details on the addition of the 2D barcode.

02/10/15	1.8	Added I2C Slave Monitor Mode Can Lock The I2C Bus and I2C Transaction Corruption In Slave Receiver Mode .
10/19/15	1.9	Added Under Very Rare Timing Circumstances, Transition Into Streaming Mode Might Create A Data Corruption and When ECC Is Enabled, The CHE_CORR_ECC_ADDR_REG_OFFSET Register Might Report An Incorrect Column Address .
09/27/16	1.10	Added single-core devices (XC7Z007S, XC7Z012S, and XC7Z014S) to Table 1 . Updated System Deadlock Can Occur In SMP Mode When The Same Cache Line Is Accessed By Both CPUs And The ACP .
05/22/17	1.11	Updated Traceability and Figure 1 with 2D barcode information.
