Introduction

Thank you for designing with the Zynq® UltraScale+™ MPSoC family. Although Xilinx has made every effort to ensure the highest possible quality, the devices listed in [Table 1](#) are subject to the limitations described in the following errata.

Table 1: Devices Affected by These Errata

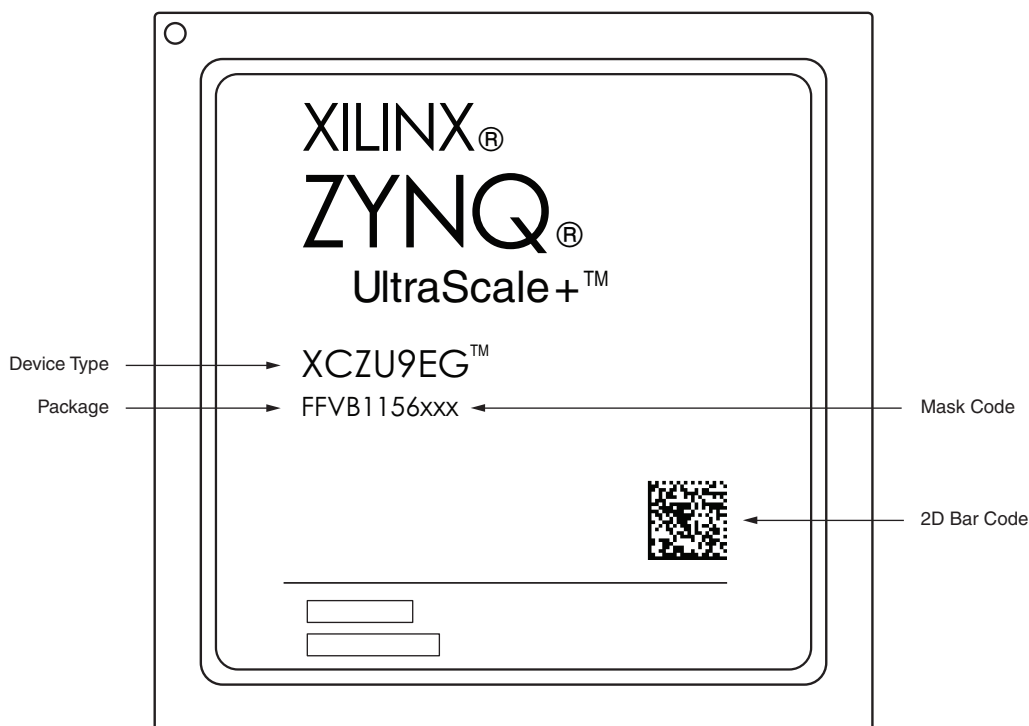
Figure 1: Example Device Top Mark

Figure 1 shows an example device top mark for the devices listed in Table 1.
