Introduction

Thank you for designing with the Zynq® UltraScale+™ MPSoC family. Although Xilinx has made every effort to ensure the highest possible quality, the devices listed in [Table 1](#) are subject to the limitations described in the following errata.

Table 1: Devices Affected by These Errata

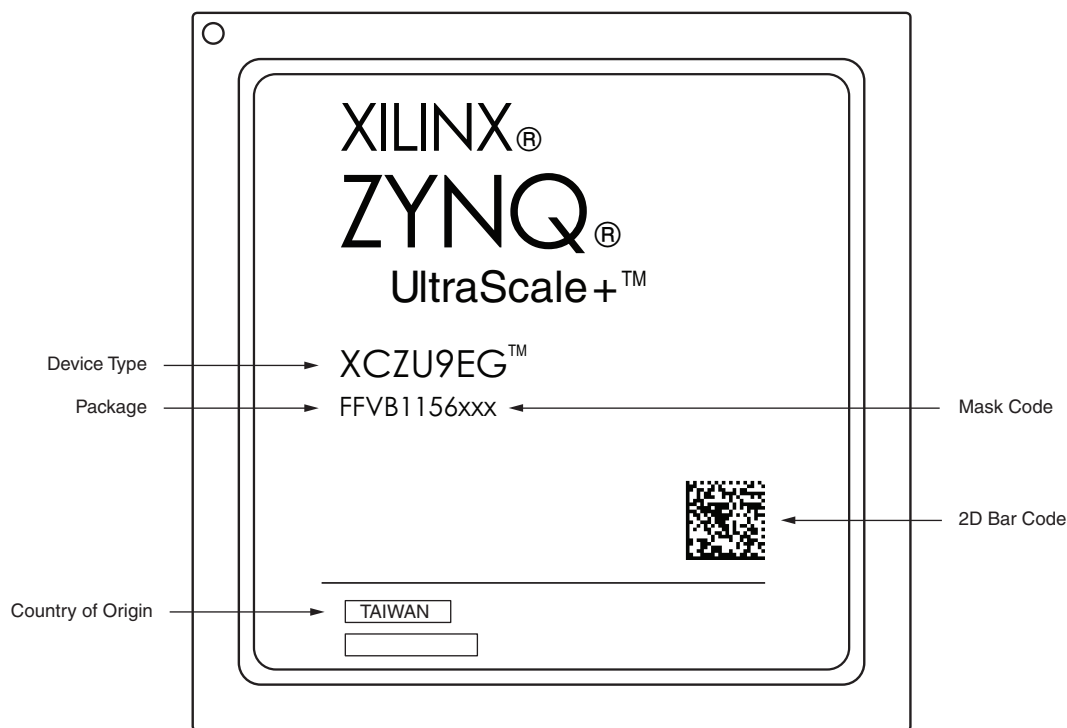
Figure 1: Example Device Top Mark

[Figure 1](#) shows an example device top mark for the devices listed in [Table 1](#). Note that the XQ Zynq UltraScale+ device top mark includes only the Xilinx logo, 2D bar code, and country of origin.
