Introduction

Thank you for designing with the Zynq® UltraScale+™ RFSoc family. Although Xilinx has made every effort to ensure the highest possible quality, the devices listed in [Table 1](#) are subject to the limitations described in the following errata.

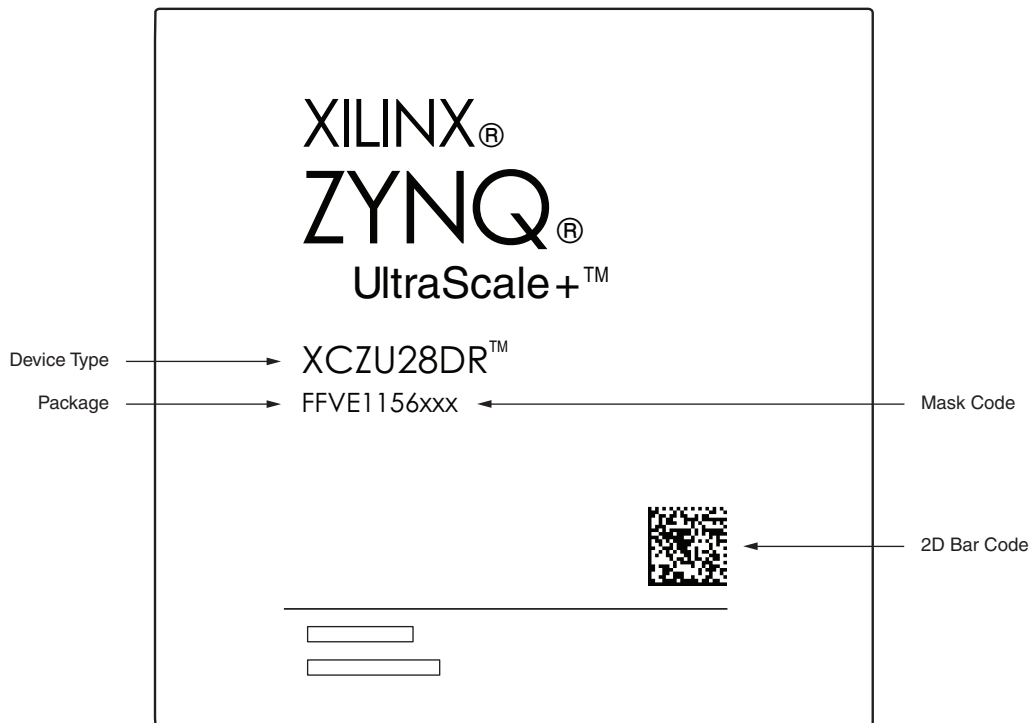
Figure 1: Example Device Top Mark

Figure 1 shows an example device top mark for the devices listed in Table 1.
